ALTEC INC.

**FINAL REPORT TO:
SAMPLE REPORT**

TABLE OF CONTENTS

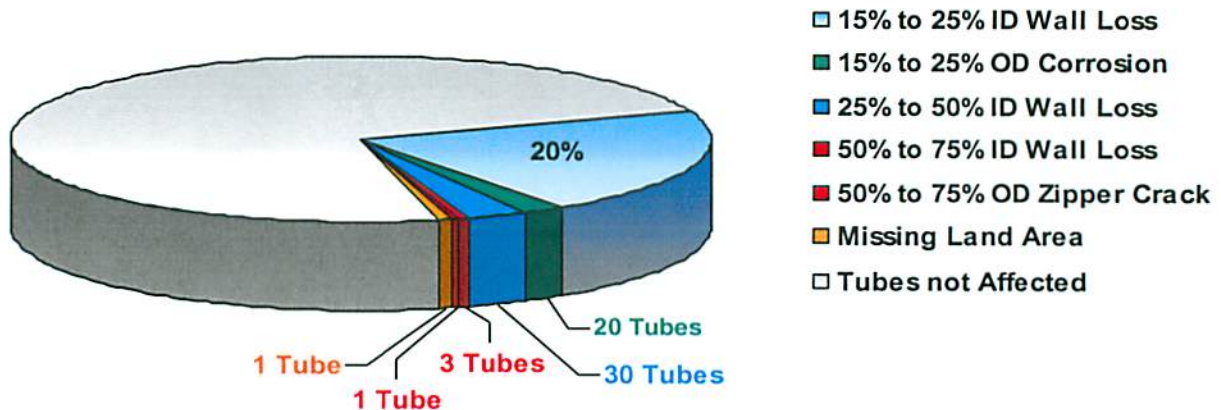
Of the 1048 tubes tested in the condenser, there were indications indicative of the following;

- 20 Category #1 OD Corrosion (15% to 25%)
- 30 Category #2 ID Wall Loss (25% to 50%)
- 3 Category #3 ID Wall Loss (50% to 75%) **Recommend to Plug**
- 1 Category #3 OD Zipper Crack (50% to 75%) **Recommend to Plug**
- 1 Missing Land Area
- 2 Mechanical Plug

Note: There was approx. 20% of the tubes that exhibited signals indicative of Category #1 ID wall loss. This is considered minor, and is noted for comparison in future inspections only.

** It is recommended to re-test this unit in 3 years to monitor any change in tube integrity.

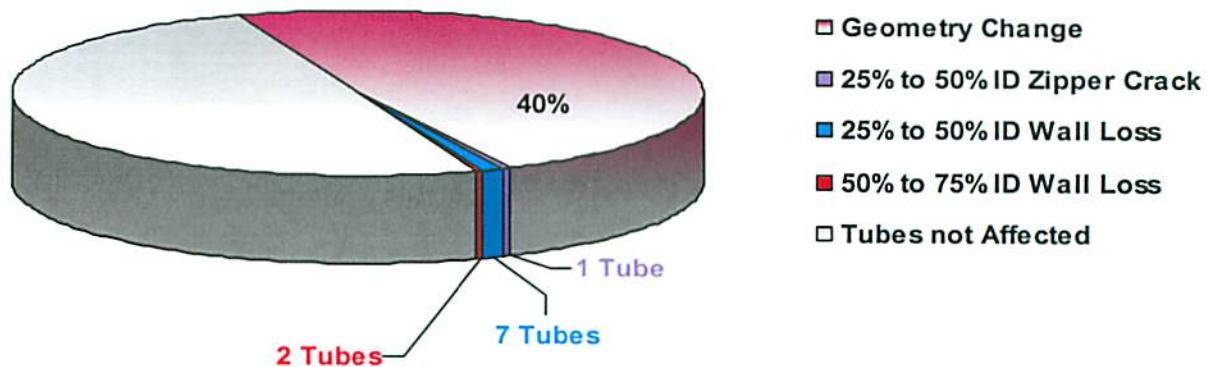
Of the 818 tubes tested in the evaporator, there were indications indicative of the following;

- 1 Category #2 ID Zipper Crack (25% to 50%)
- 7 Category #2 ID Wall Loss (25% to 50%)
- 2 Category #3 ID Wall Loss (50% to 75%) **Recommend to Plug**

Note: Approx. 40% of the tubes exhibited signals indicative of manufacturing geometry changes.

** It is recommended to re-test this unit in 3 years to monitor any change in tube integrity.

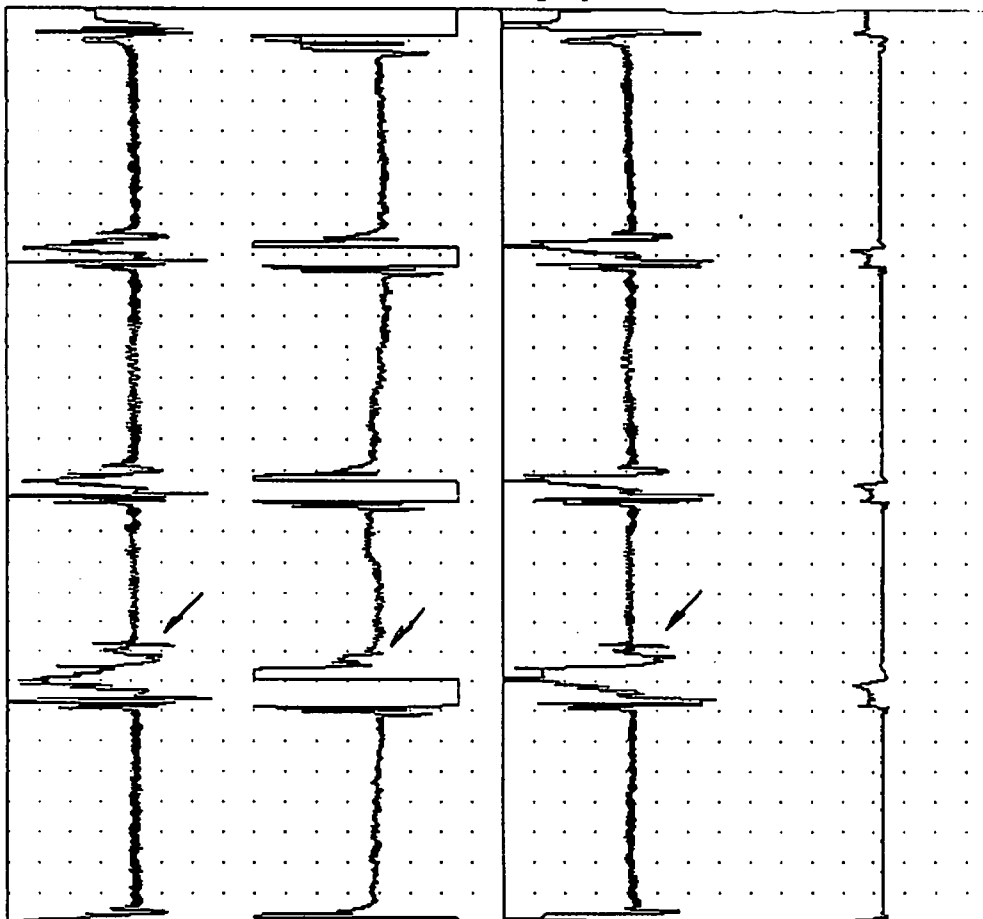
Condenser Row 10 Tube 1 Category #2 ID Pit

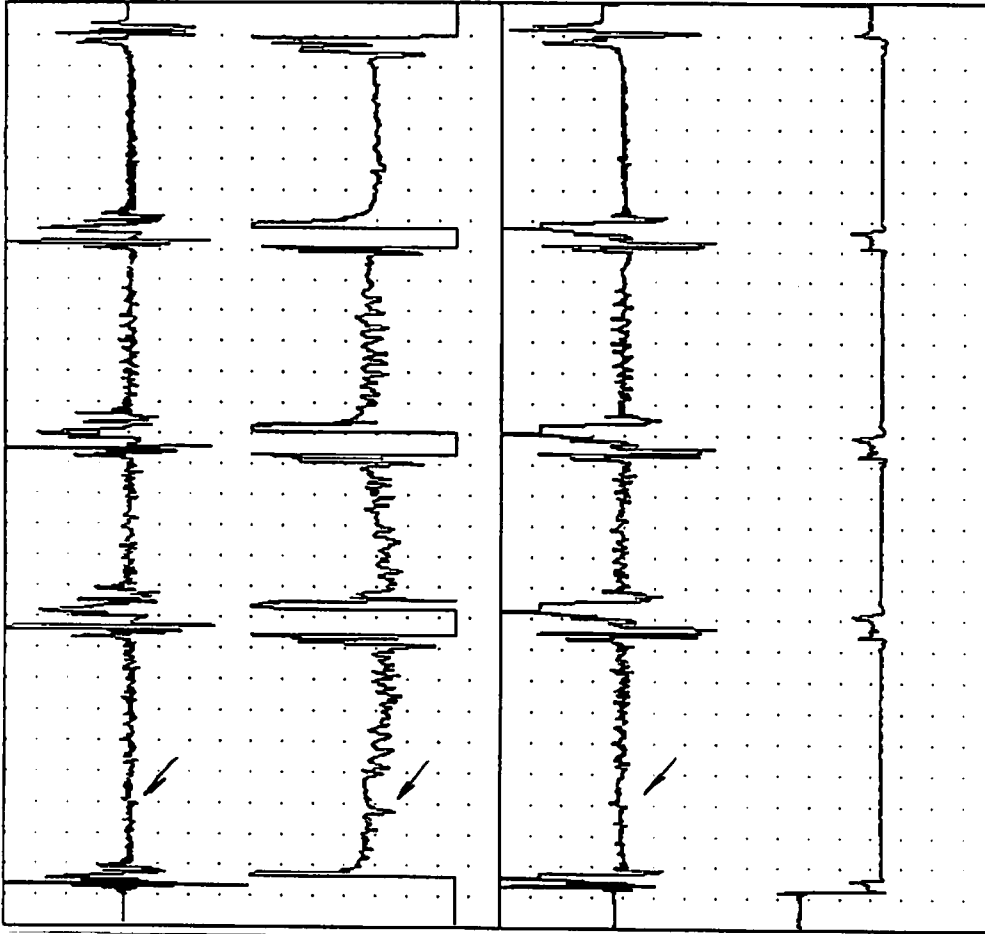
Condenser Row 13 Tube 5 Category #3 ID Pit

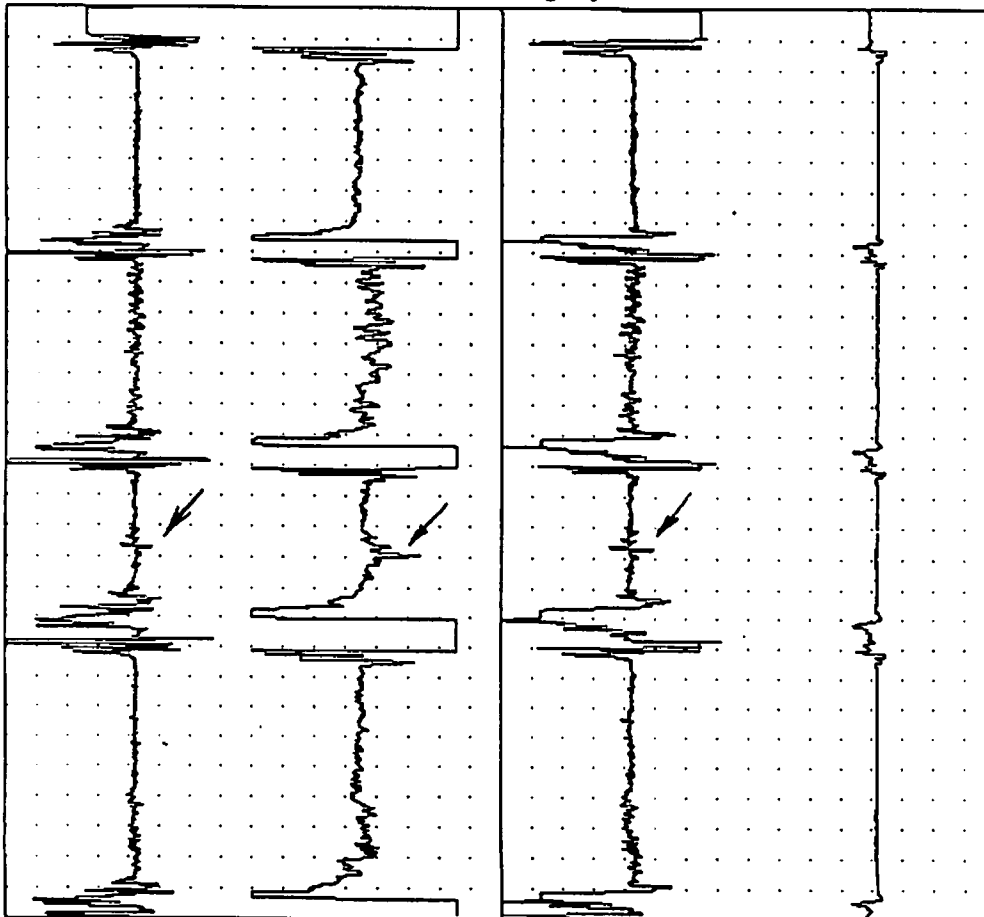
Condenser Row 14 Tube 8 Category #3 ID Pit

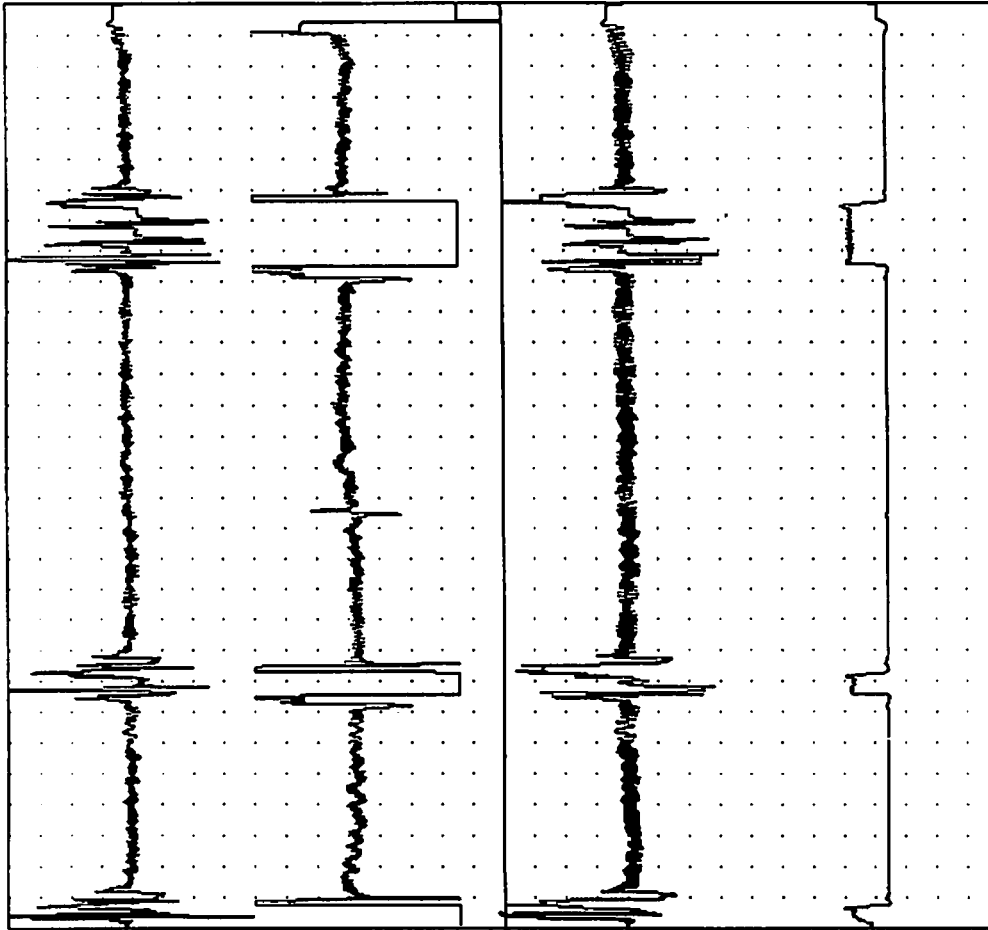
Condenser Row 16 Tube 23 Missing Land Area

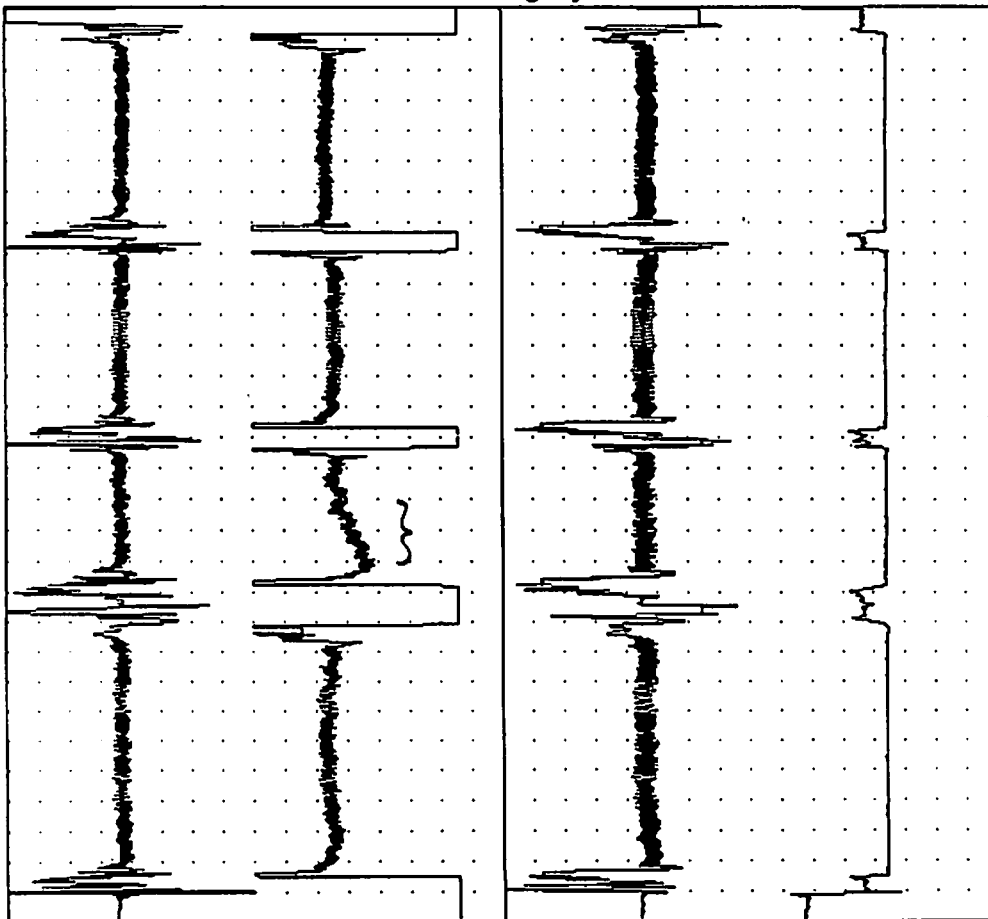
Condenser Row 22 Tube 2 Category #1 OD Corrosion

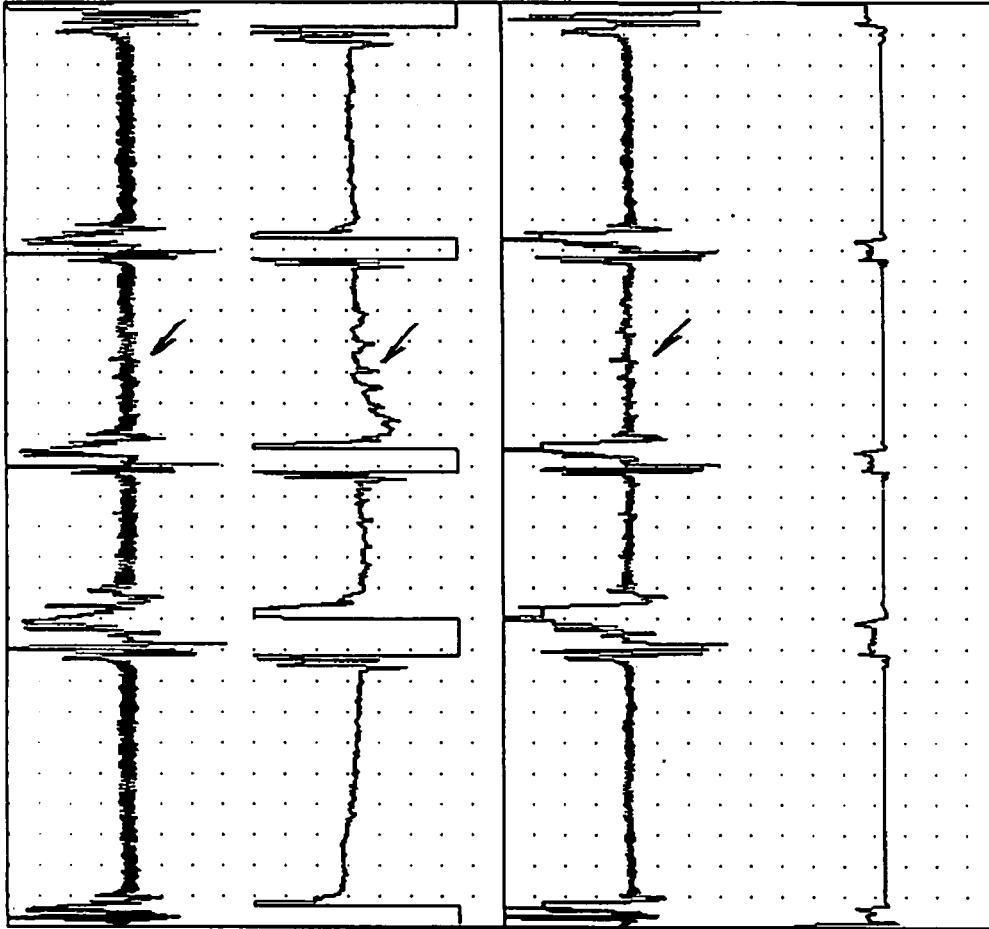
Condenser Row 29 Tube 8 Category #2 ID Pit

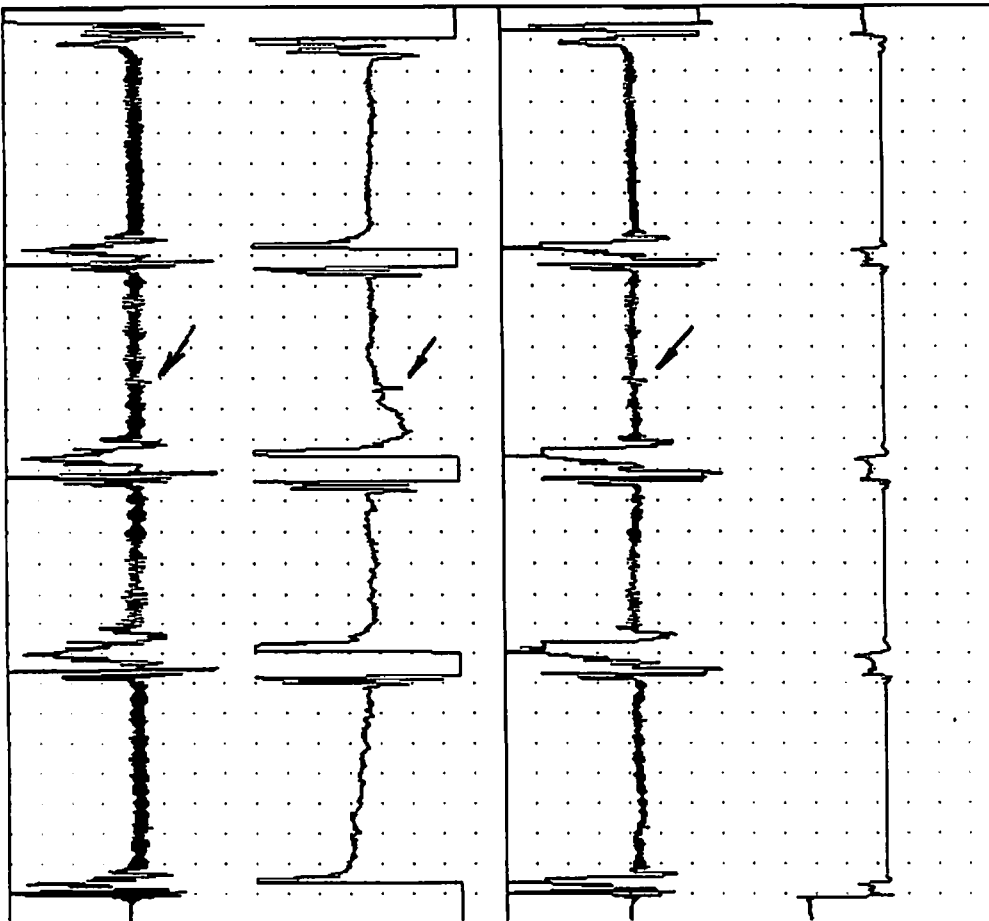
Condenser Row 29 Tube 9 Category #2 ID Pit

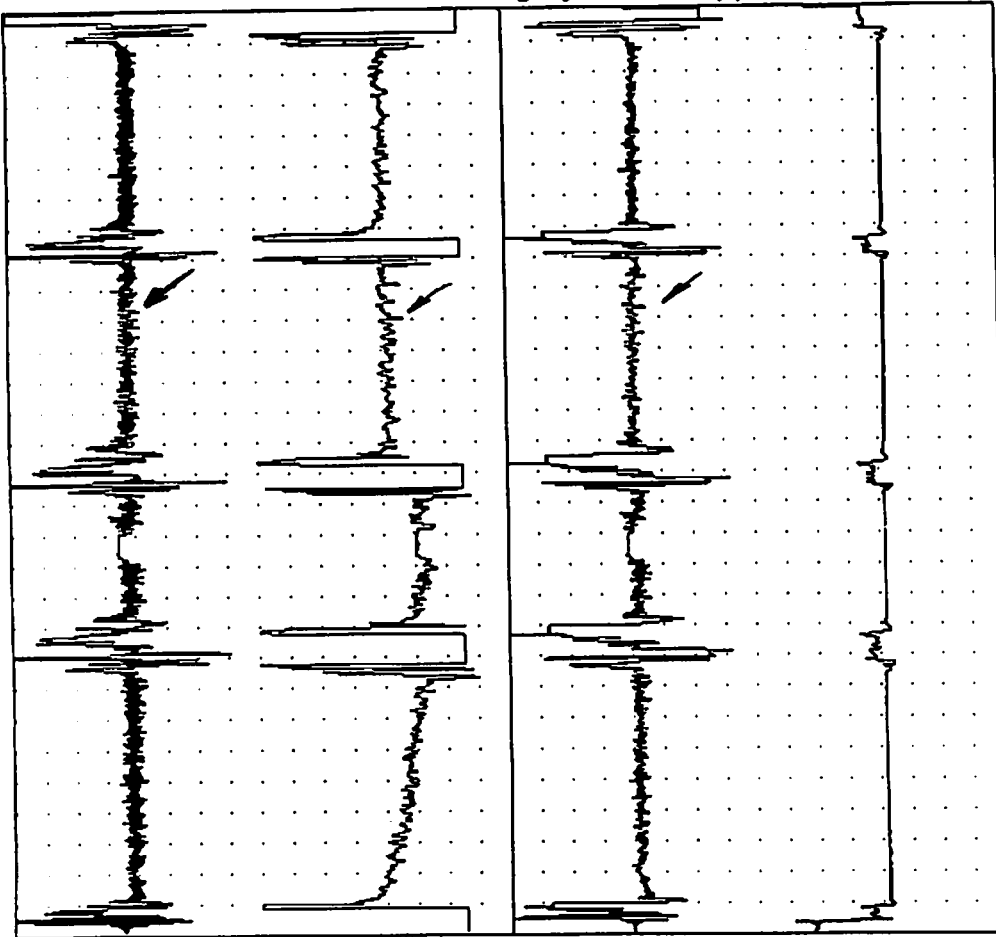
Condenser Row 31 Tube 4 Category #3 OD Zipper Crack

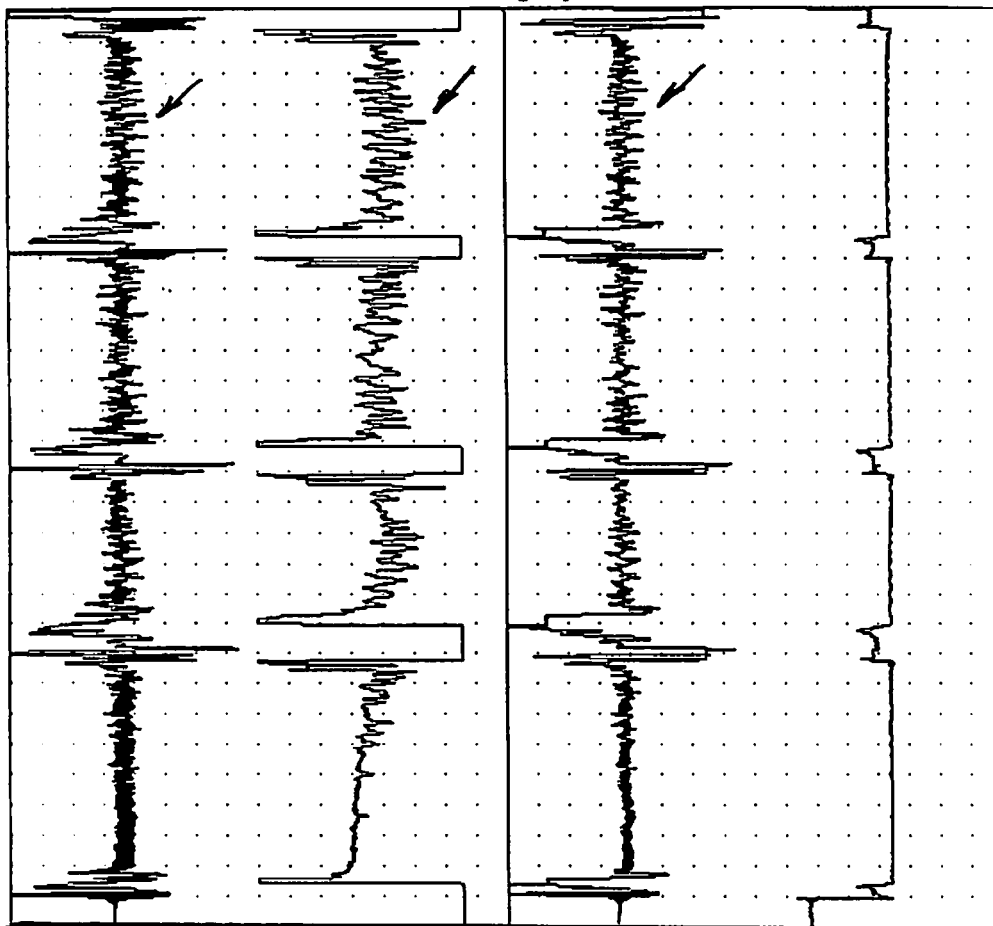
Condenser Row 32 Tube 5 Category #3 ID Pit

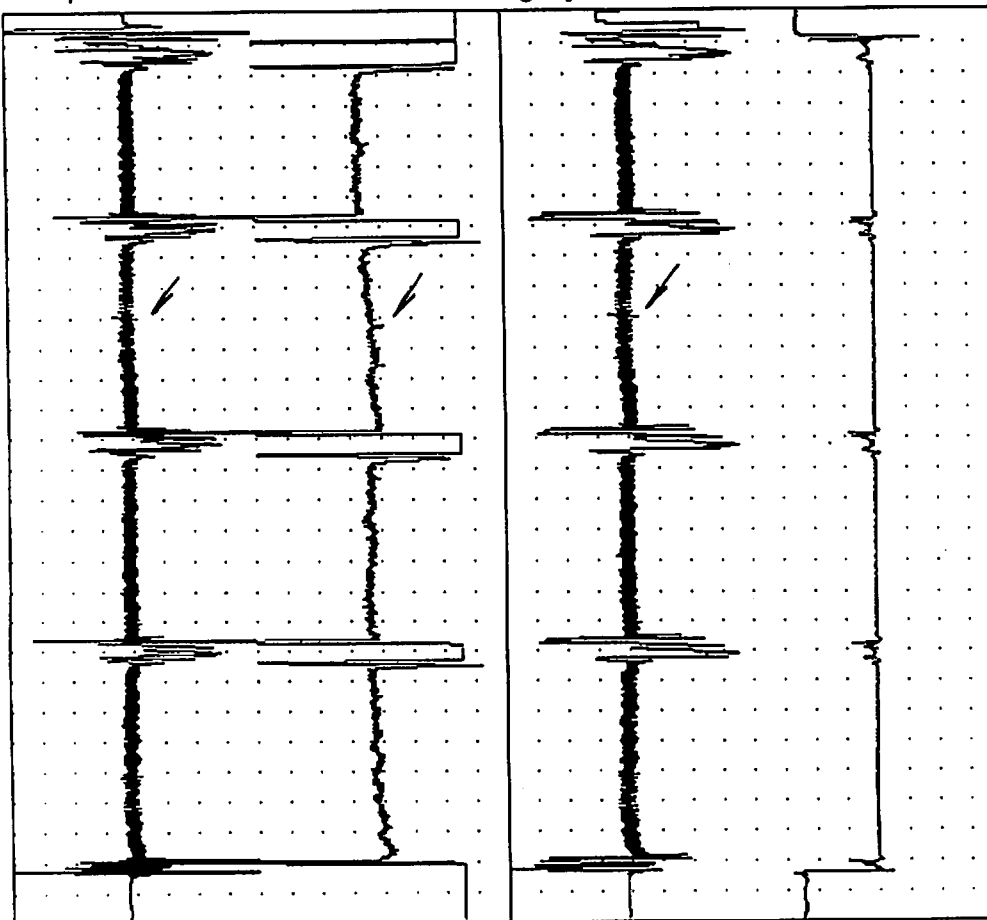
Evaporator Row 1 Tube 23 Category #2 ID Pit

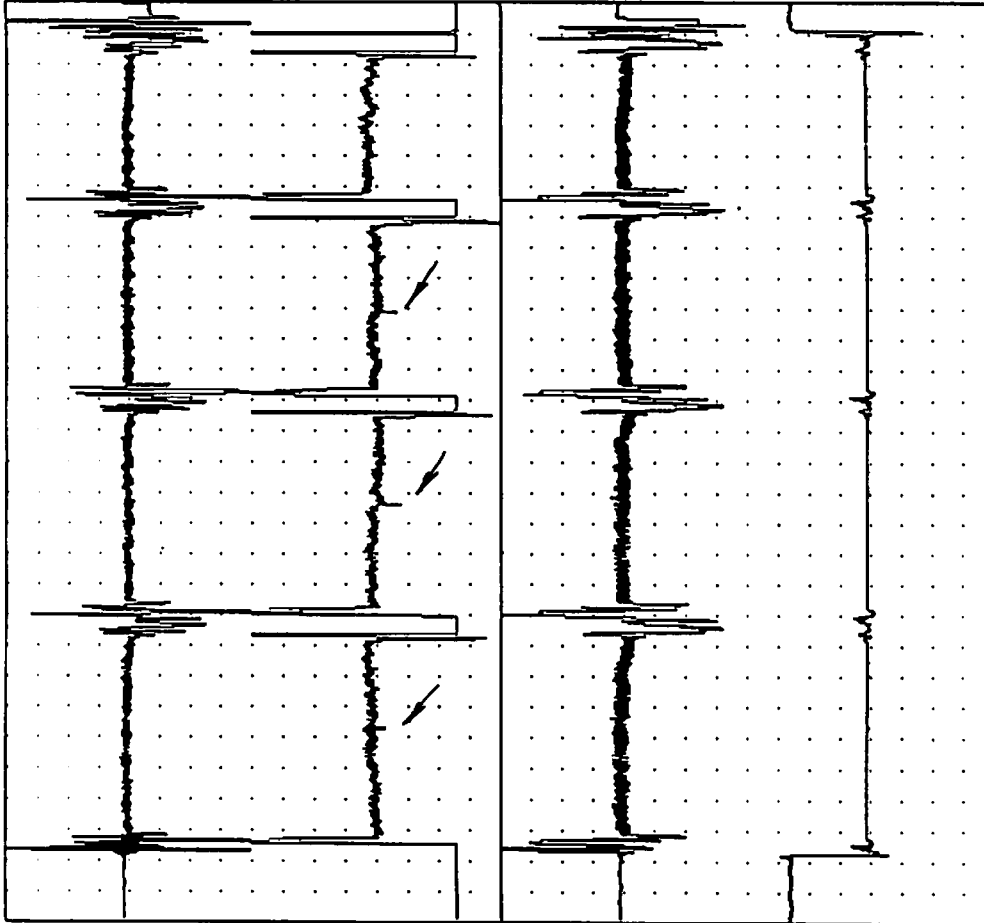
Evaporator Row 5 Tube 25 Sample Geometry Change

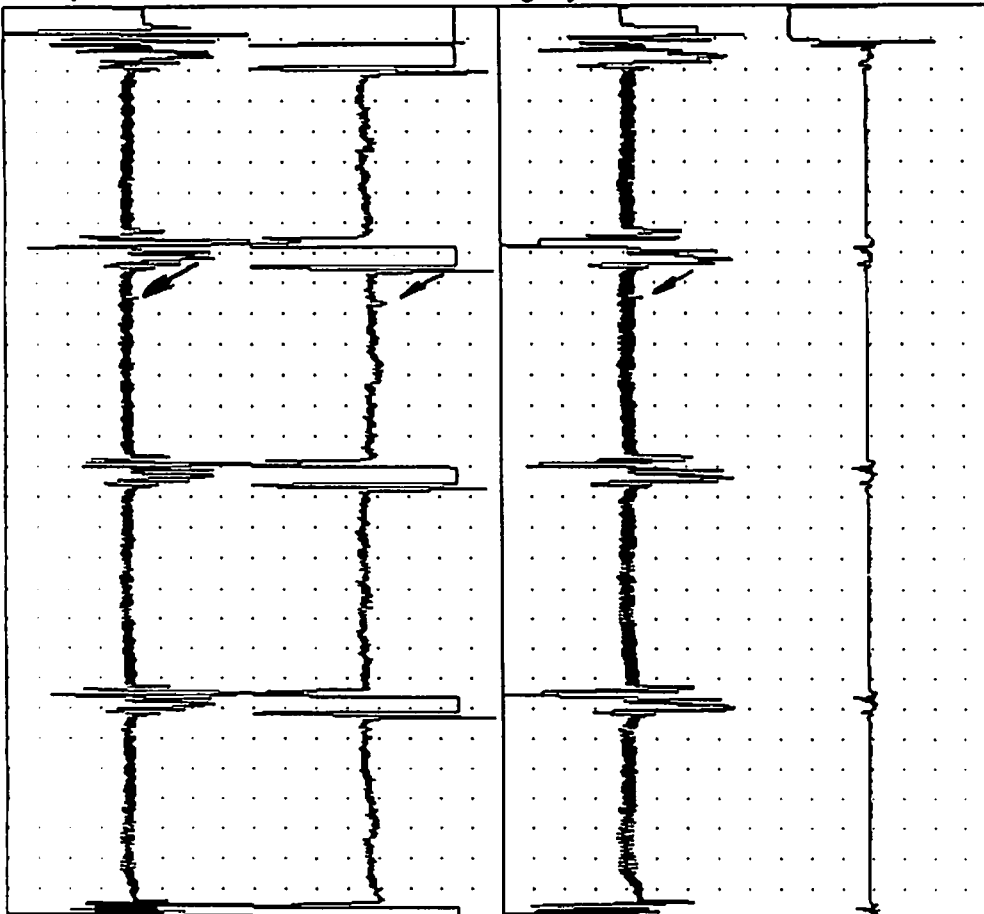
Evaporator Row 7 Tube 50 Category #3 ID Pit

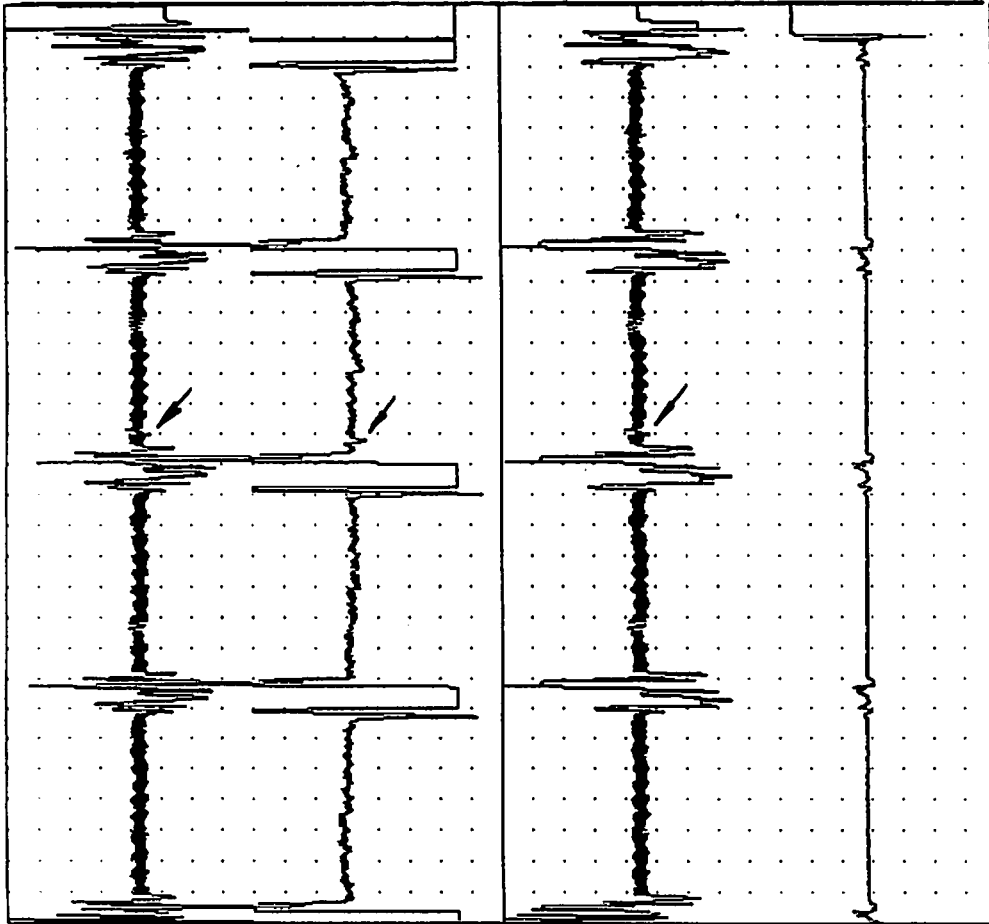
Evaporator Row 8 Tube 26 Category #3 ID Pit

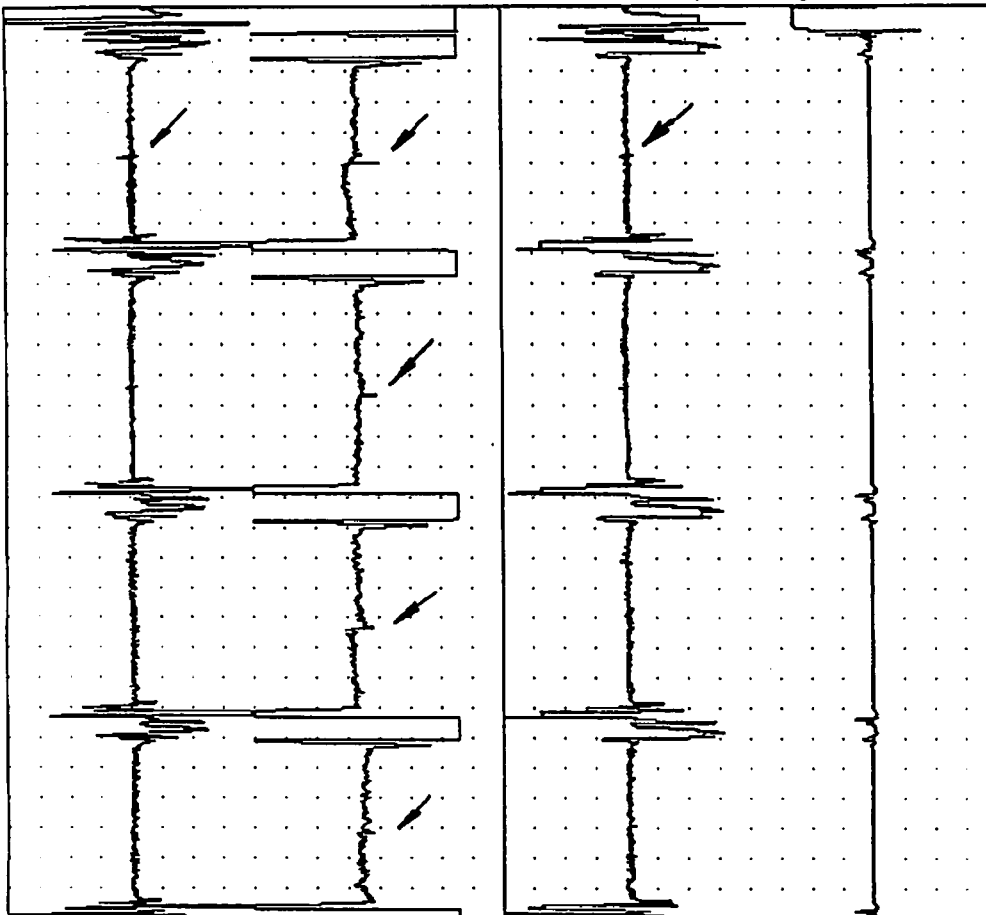
Evaporator Row 10 Tube 42 Sample Geometry Change
